Countermeasures to Improve Pedestrian Safety on Arterials:

Design Recommendations for Urban NMDOT Roadways

Final Report

Report R922070

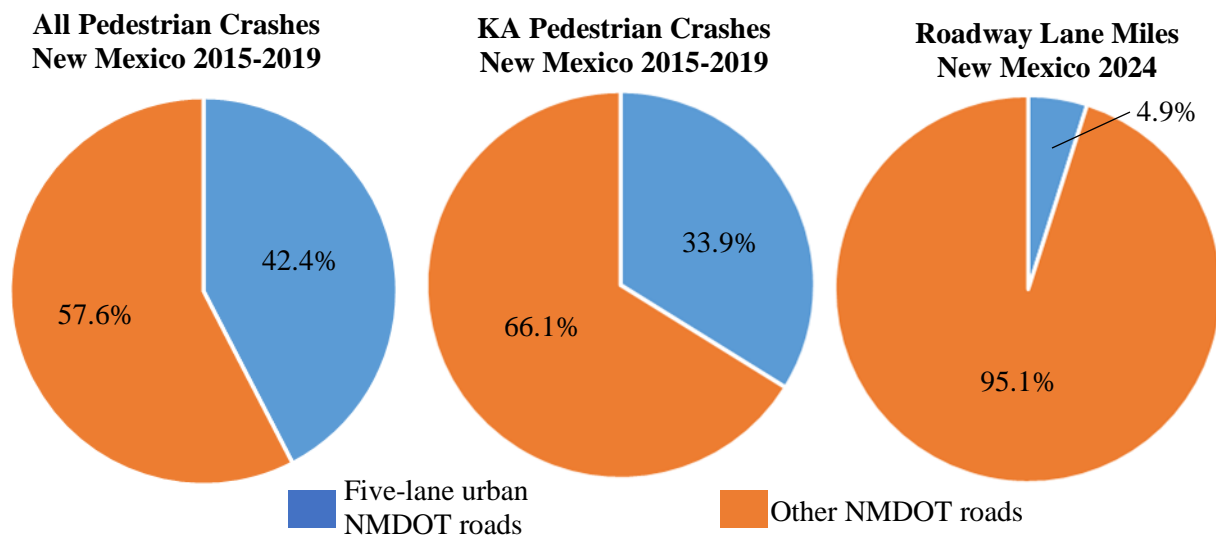
FIGURE 23. Distribution of pedestrian crashes relative to NMDOT roads and urban five-lane configurations.

Specifically examining NMDOT roads, 42.4% of pedestrian crashes and 33.9% of pedestrian KA crashes that occur on NMDOT roads occur on our five-lane urban road type, despite the fact that the road type only makes up 4.9% of all NMDOT lane miles (Figure 23).

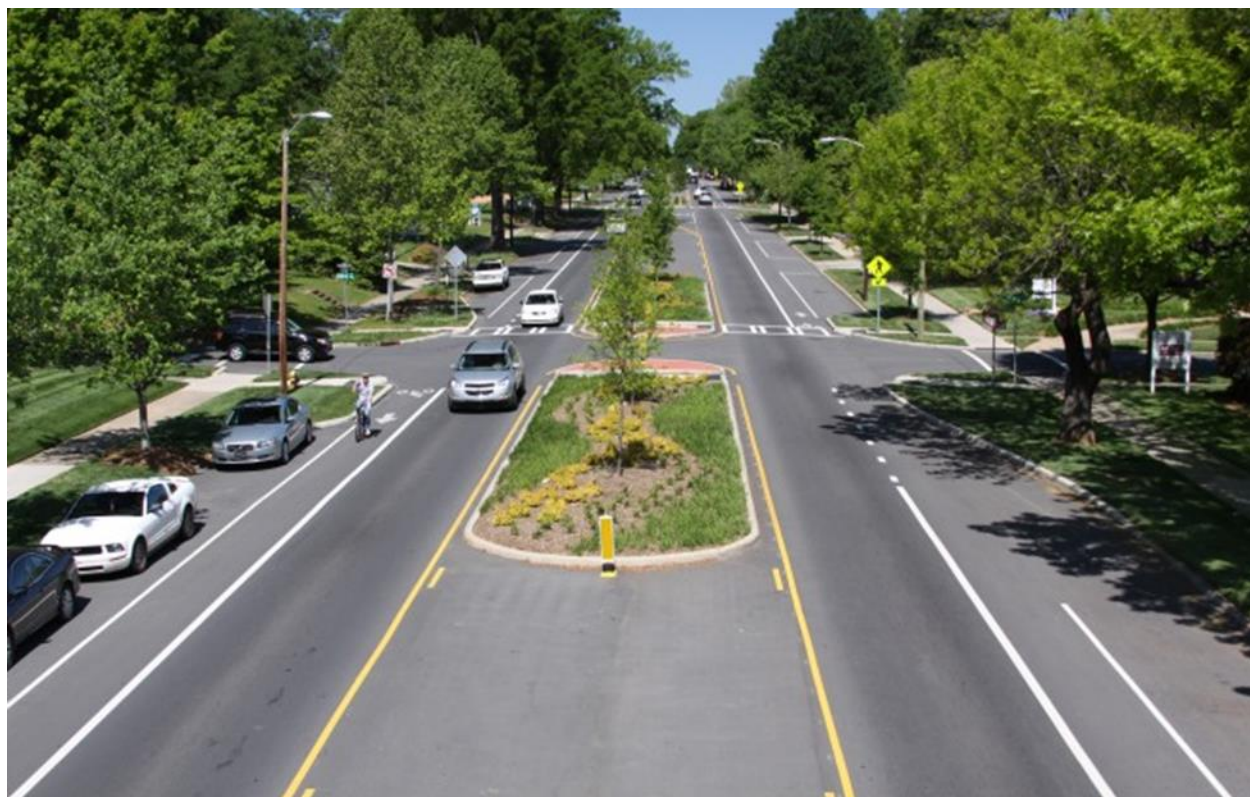
FIGURE 33. Pedestrian crossing on East Boulevard in Charlotte, NC after road redesign (Photo: City of Charlotte)
